Observations of New and Reprocessed Octopus 3[®] Tissue Stabilizers and Octopus4[®] Tissue Stabilizers

The objective of this study was to evaluate new sterile and reprocessed sterile Medtronic Octopus 3[®] and Octopus 4[®] Tissue Stabilizers (see attached product PDF files). A report dated May 24, 2004 contained information and data describing the differences observed between new sterile and reprocessed sterile Medtronic Octopus 3[®] and Octopus 4[®] Tissue Stabilizers. In that report a total of four devices were assessed, one new sterile Medtronic Octopus 3[®], one new sterile Medtronic Octopus 4[®], one reprocessed sterile Medtronic Octopus 3[®] (SterilMed) and one reprocessed sterile Medtronic Octopus 4[®] (Alliance). Subsequent to that report, eight additional reprocessed Medtronic Octopus 3[®] and Octopus 4[®] Tissue Stabilizers from the same two reprocessors were examined using similar microscopic and molecular techniques. On June 7, 2004 the additional reprocessed Medtronic Octopus 3[®] and Octopus 4[®] Tissue Stabilizers were received. Results of eight of those are contained in this study for a total of twelve devices, two new sterile devices and ten reprocessed devices.

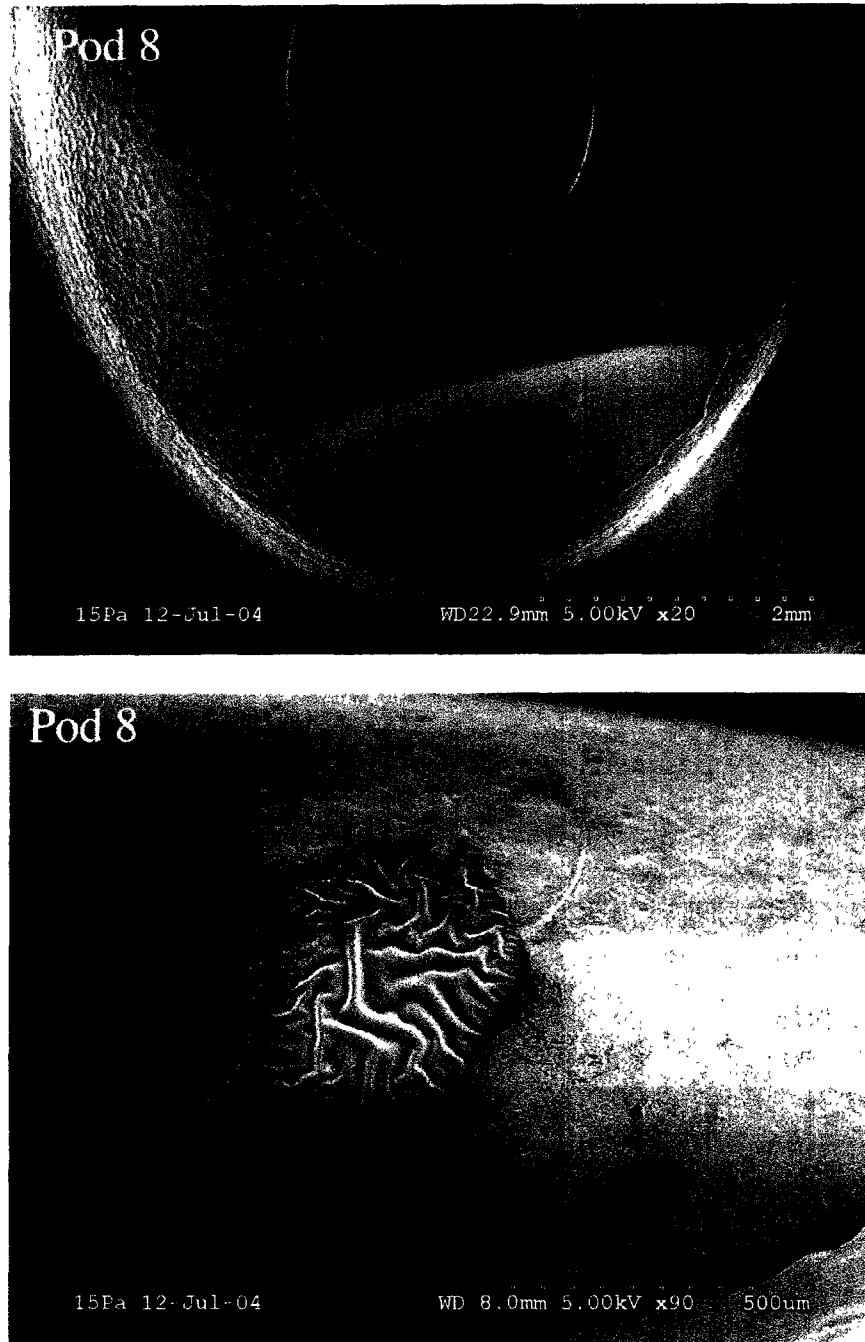
Figure 74. Images collected from Hitachi S3500N variable pressure scanning electron microscope in the areas of pod 8 on the **reprocessed Octopus 4[®] MT-104-16**. Note contamination and dried liquid material near hypotube opening. The number in the upper left indicates the pod # (see Figure 5). Scale bar in each image.

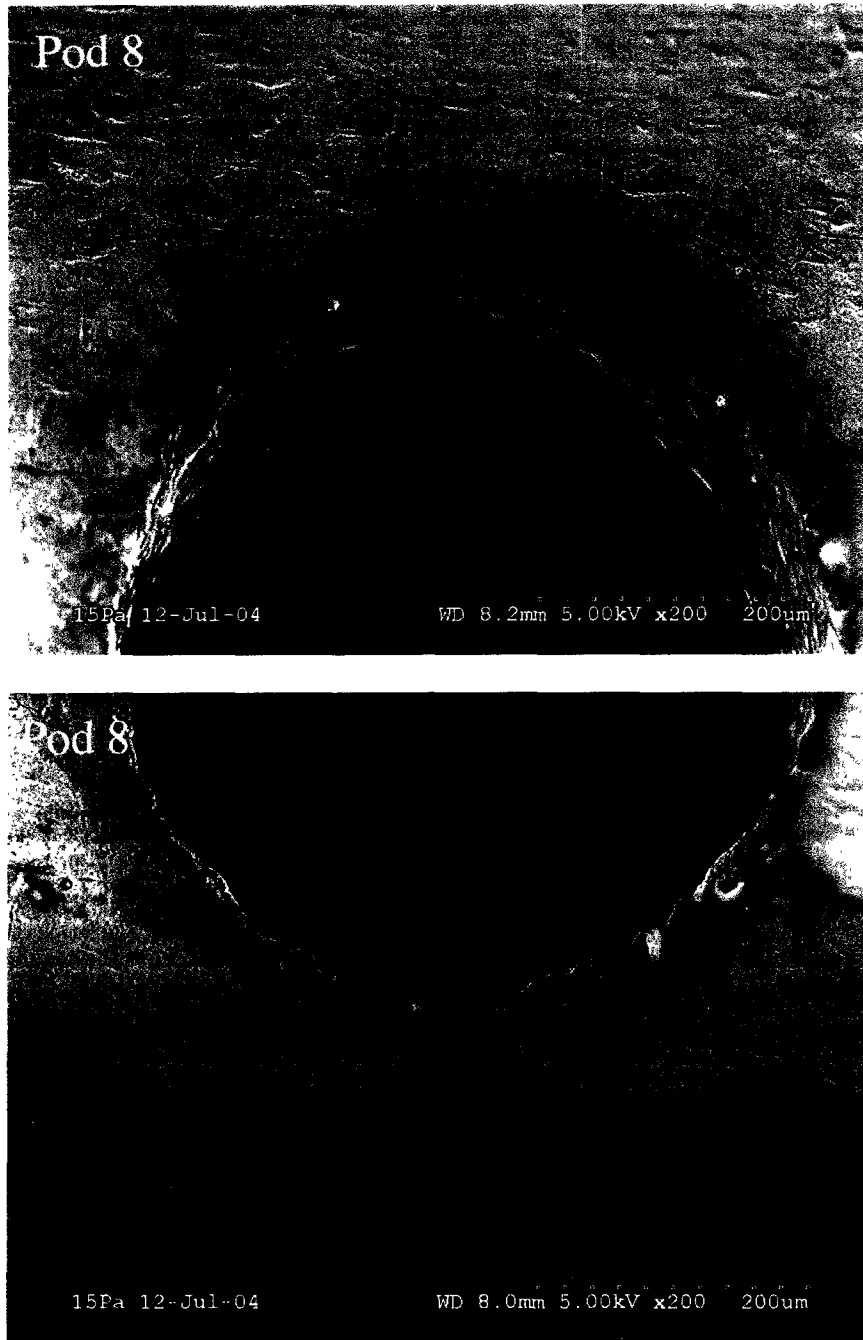
Figure 75. Images collected from Hitachi S3500N variable pressure scanning electron microscope in the areas of pod 8 on the **reprocessed Octopus 4[®] MT-104-16**. Note contamination and dried liquid material near hypotube opening. There is also debris in the opening of the hypotube. The number in the upper left indicates the pod # (see Figure 5). Scale bar in each image.
